- (5)
- (6)
- A. FATIGUE AND MICROSTRUCTURAL PROPERTIES
OF QUENCHED Ti-6Al-4V,
- B. A CRYSTALLOGRAPHIC STUDY OF FATIGUE
DAMAGE IN TITANIUM.
- C. CORROSION AND CORROSION-FATIGUE BEHAVIOR OF
Ti-4.5Al-5Mo-1.5Cr (CORONA 5) AND Ti-6Al-4V.
- by

9 Final Report
September 1980

Prepared Under Contract N00019-78-C-0269

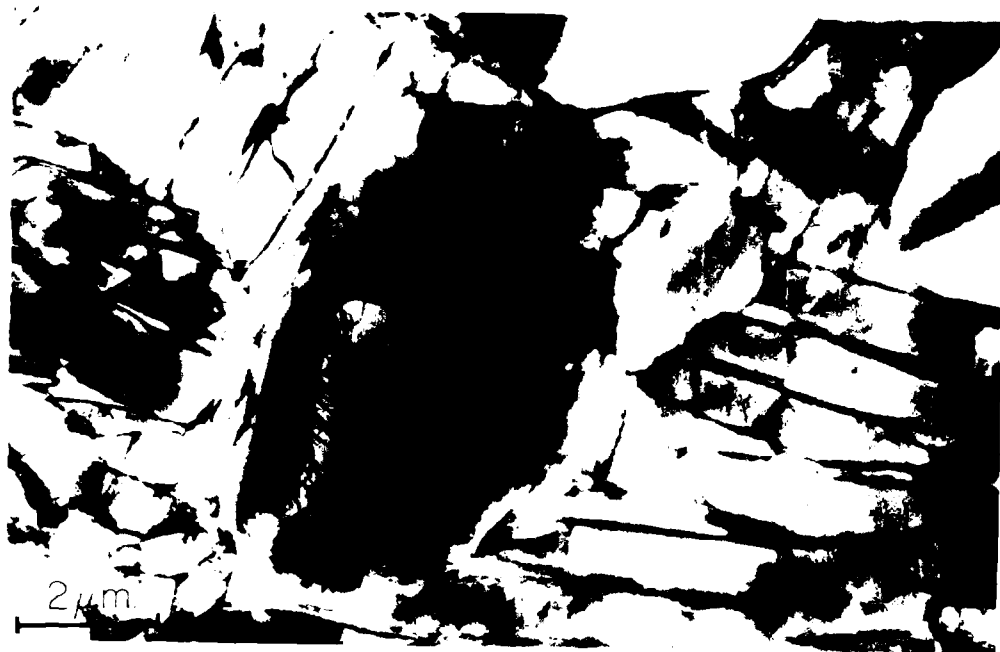
Figure 16. Transmission electron micrograph of the same specimen as in Figure 15 showing boundary Ti-Ti-6Al-4V.

- Figure 15. Optical Micrograph of Ti-6Al-4V Heat Treated at 900°C (1650°F) and Water Quenched Followed by Aging at 760°C (1400°F) for One Hour
- Figure 16. Transmission Electron Micrograph of the Same Specimen as in Figure 15 Showing α -Ti and Grain Boundary β -Ti

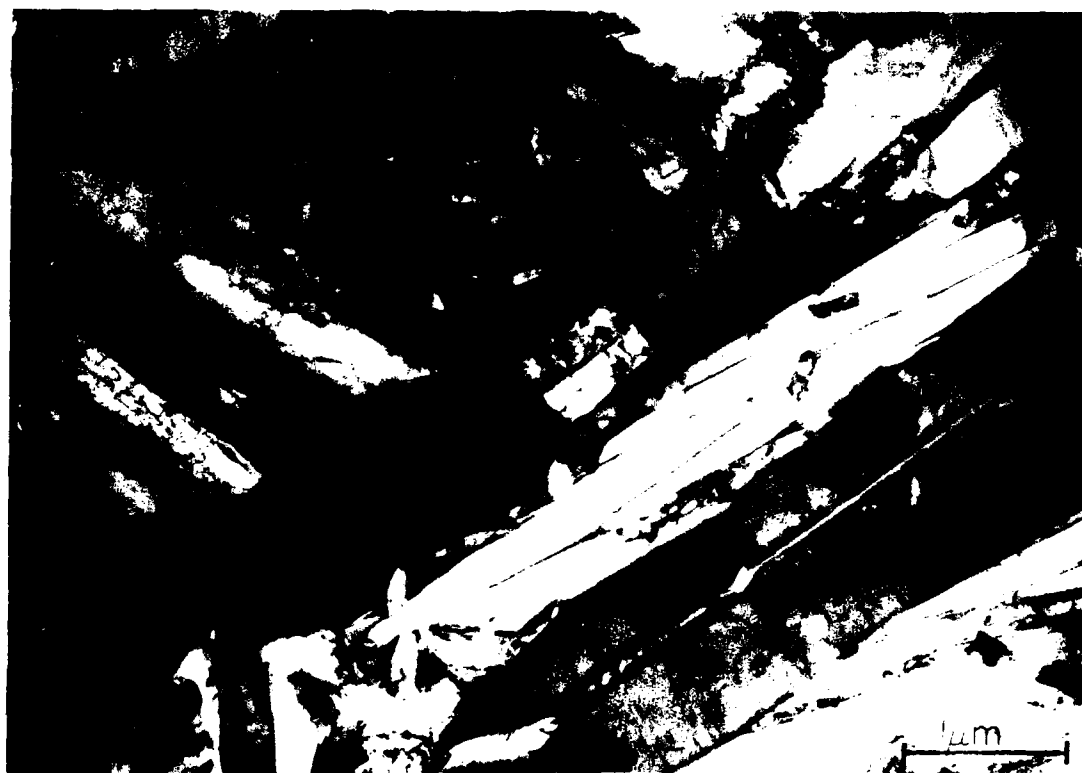
Figure 22. Transmission electron micrograph of the same specimen as in Figure 21. The electron diffraction pattern indexes to be α' (hexagonal) martensite.

- Figure 21. Optical Micrograph of Ti-6Al-4V Solution Treated at 1065°C (1950°F) and Water Quenched Showing α' -Ti Martensite
- Figure 22. Transmission Electron Micrograph of the Same Specimen as in Figure 21. The Electron Diffraction Pattern Indexes to be α' (Hexagonal) Martensite

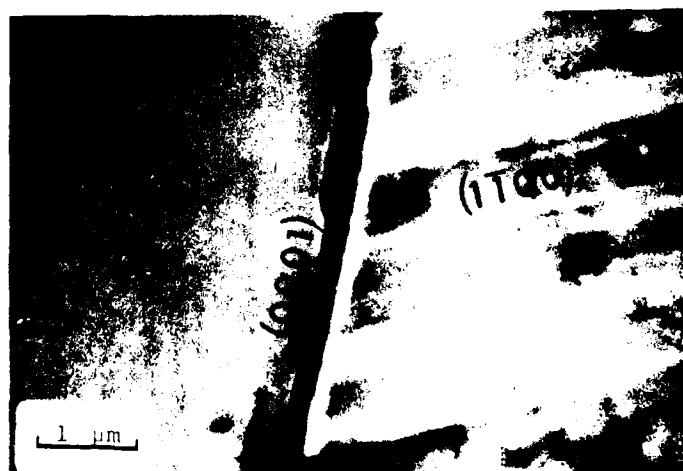
Figure 2. Cracking along a (0001) slip plane that also appears to be a subgrain boundary. Cyclic shear strain amplitude ± 0.008 .

Figure 4 shows the microstructure around a $\{11\bar{2}0\}$ tensile mode crack. The $\{11\bar{2}0\}$ plane is not a normal slip or twin plane in titanium. Comparison of Fig. 4 with Fig. 2 shows that deformation near the tensile mode crack was more severe than that near the shear mode crack. Again in Fig. 4 it was observed that fatigue deformation on one side of the crack was more severe than that on the other side.

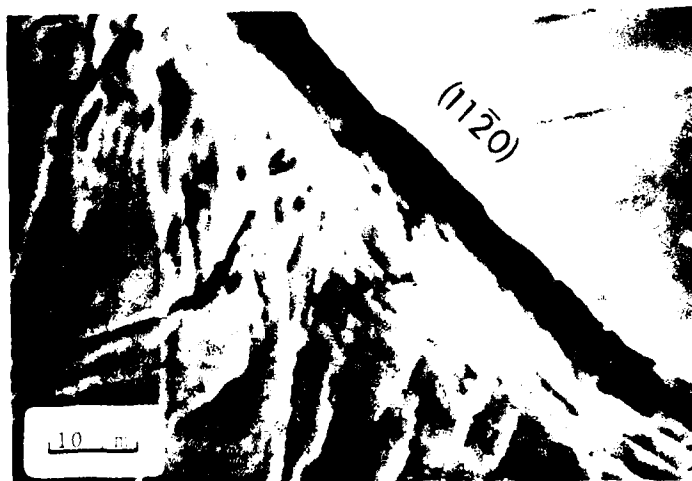
Figure 4. Severe deformation surrounding a tensile mode crack propagating on a $(11\bar{2}0)$ plane after cycling at ± 0.008 cyclic shear strain amplitude.
